**Minnkota Power**  
COOPERATIVE

# **Vegetation Mgmt. Lessons Learned**

**November 2018**

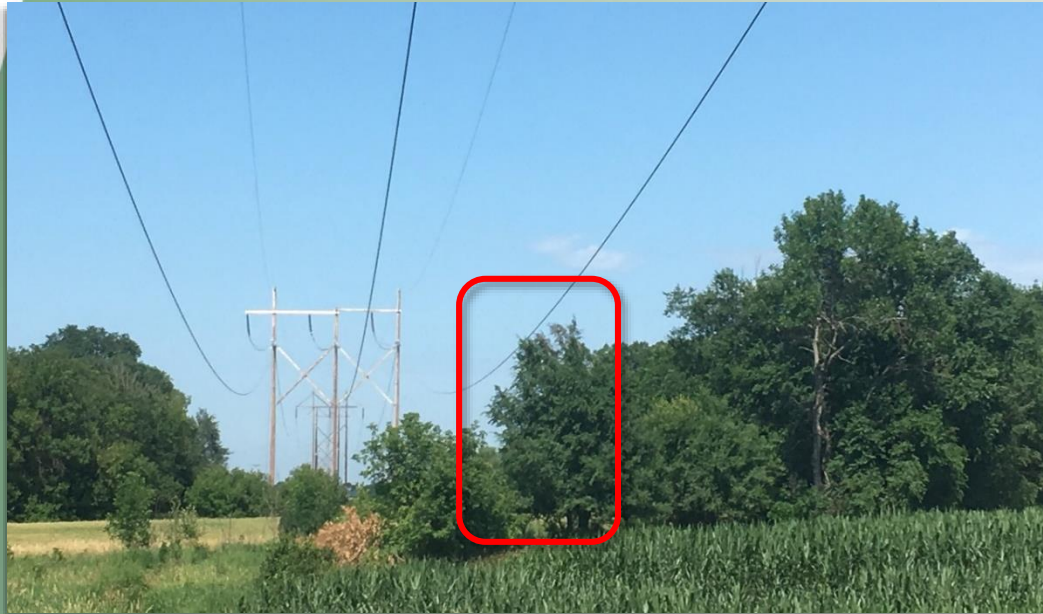
Before

- Fault on line
- Three line trips
- Scorch Marks on Tree
- No apparent contact

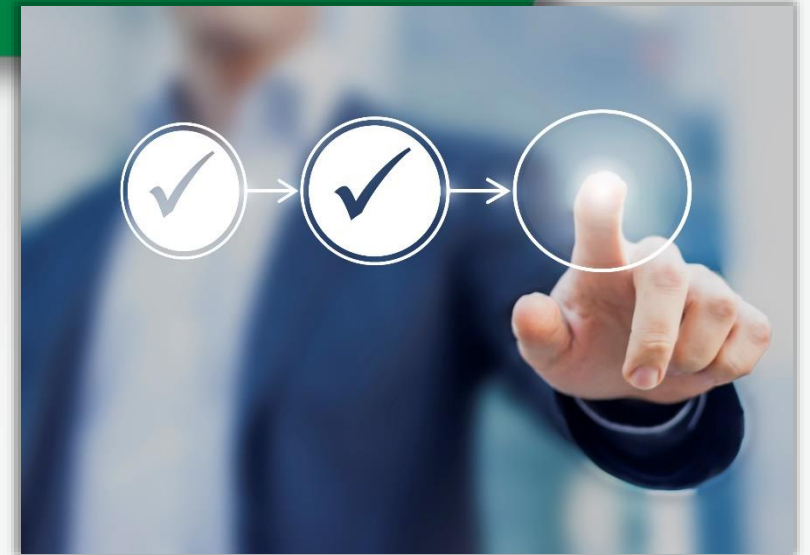
- Poor observation criteria
- Communication breakdown
- Ideal growing conditions
- Hot day

- Improving criteria related to measuring vegetation.
- Enhanced training for vegetation personnel.
- Recordkeeping and reporting improvements.

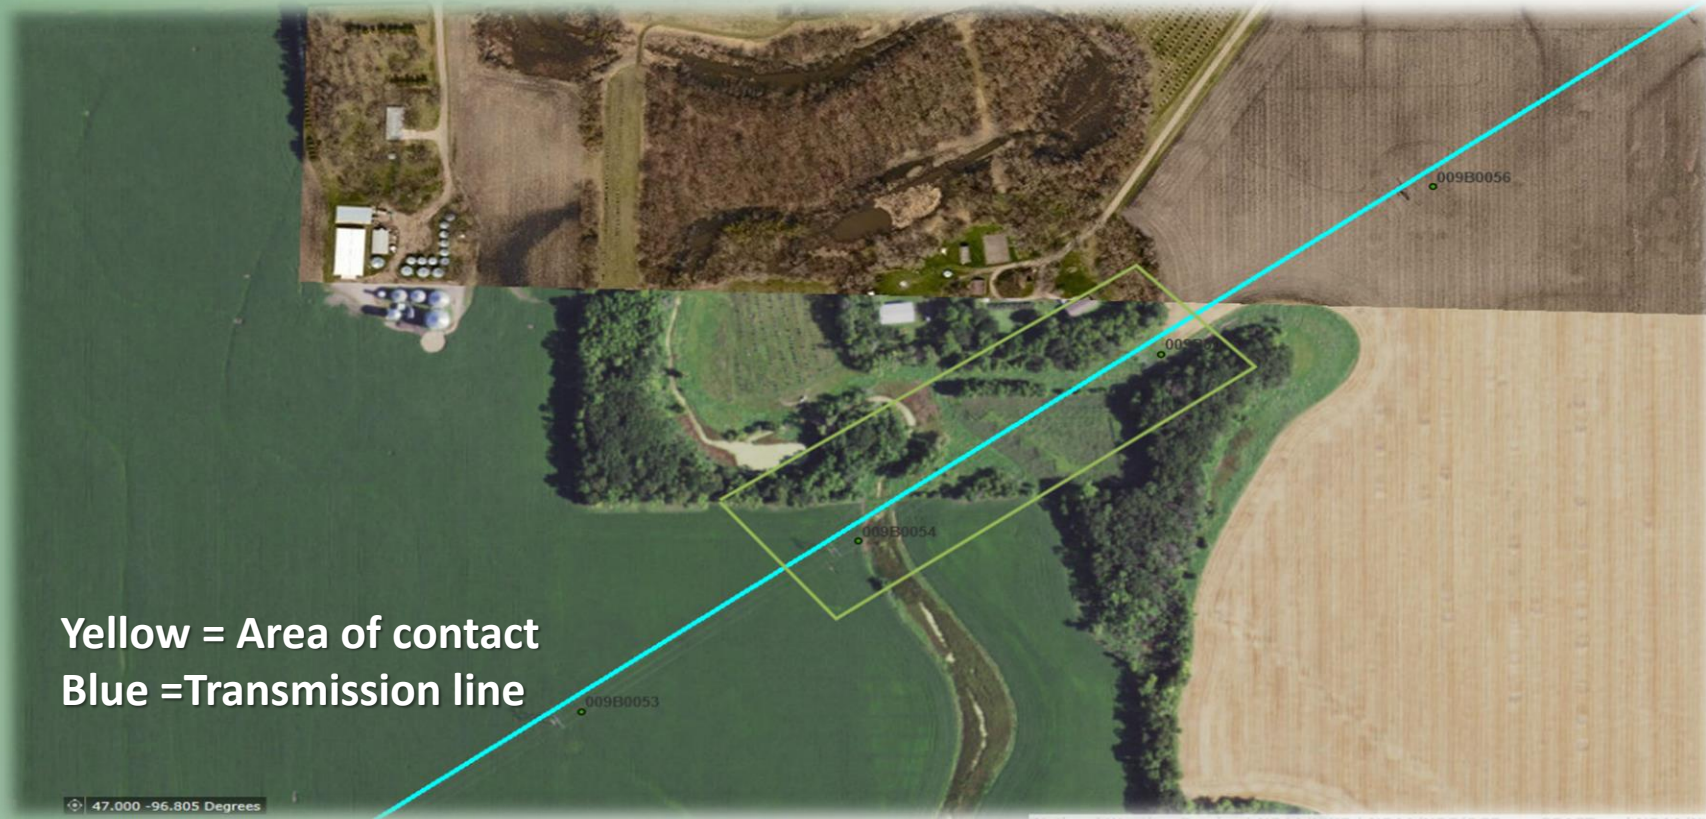
Yellow = Area of contact  
Blue = Transmission line

47.000 -96.805 Degrees
