**Minnkota Power**  
COOPERATIVE

# **Vegetation Mgmt. Lessons Learned**

**November 2018**

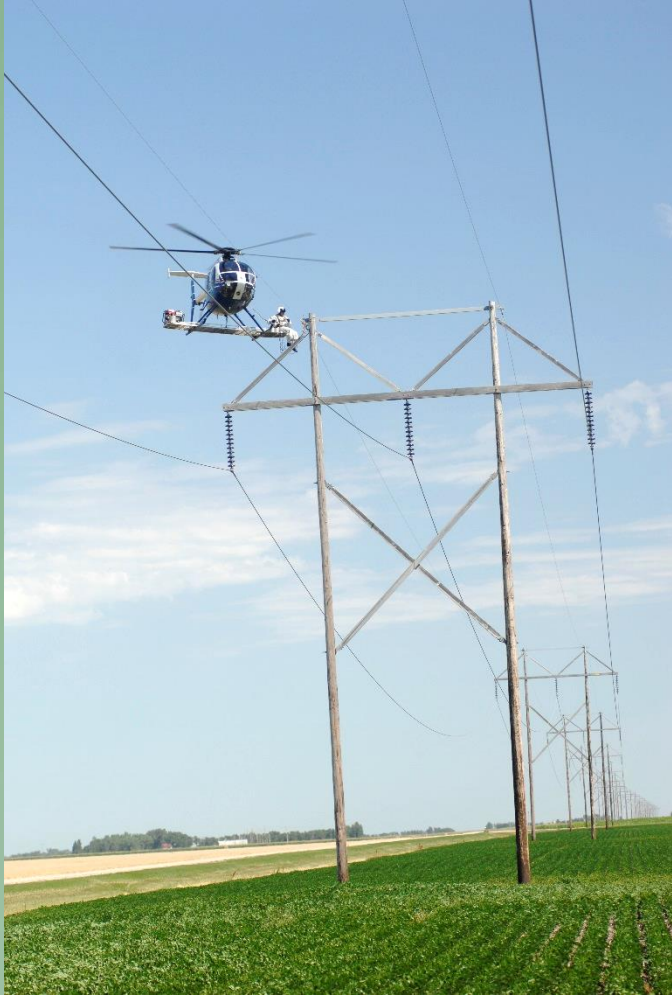
# What Happened on July 17, 2017

- Emphasis on efficiency
- Annual Helicopter Patrols
- Supplemental Fixed-Wing Patrols
- Looked for trees within 15' of conductor

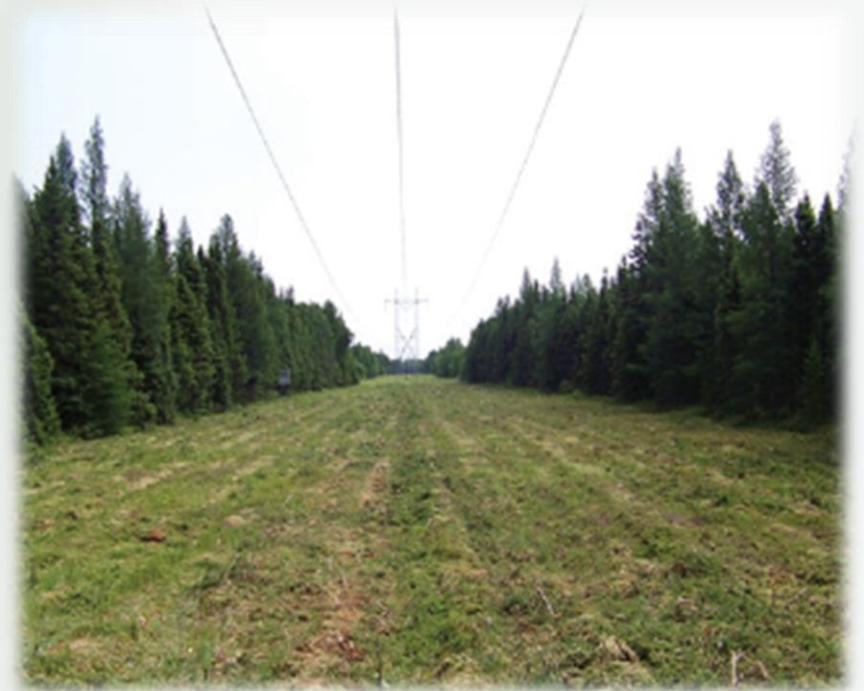
# Lesson: “Distance from conductor” isn’t ideal

- Old approach to trimming
  - Less than 15’ from conductor
  - Too subjective
  - Impossible to measure
- New approach to trimming
  - Height of tree

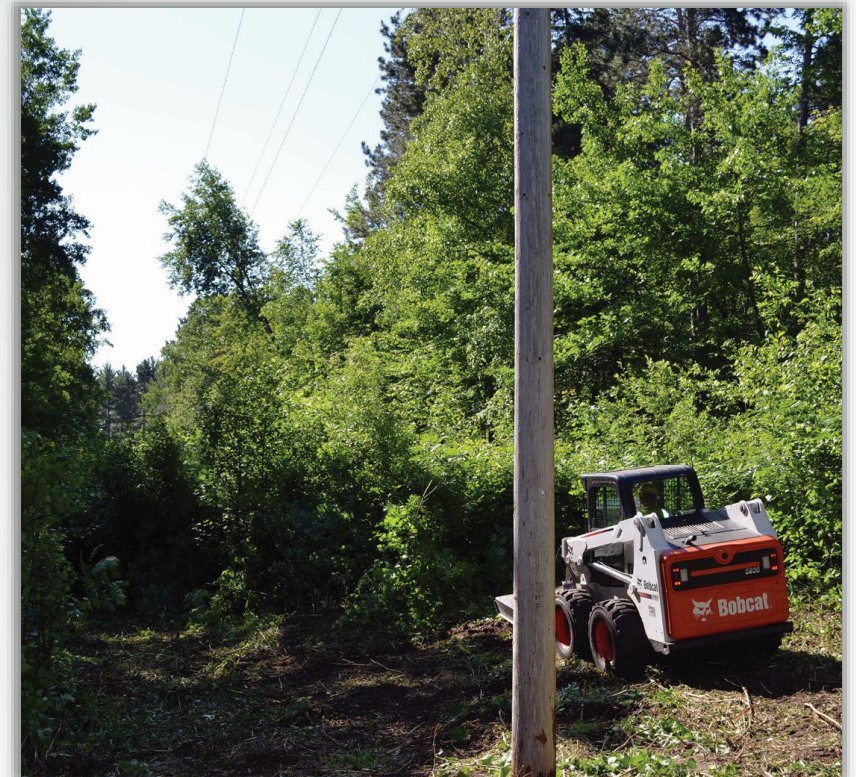
# Lesson: Address trees early

- Newly planted trees
- Volunteer trees
- Unusually wet conditions
- Err on the side of caution
