MIDWEST
RELIABILITY
ORGANIZATION

Protective Relay Subgroup (PRS)

August 16, 2022

MRO PROTECTIVE RELAY SUBGROUP Q3 MEETING AGENDA

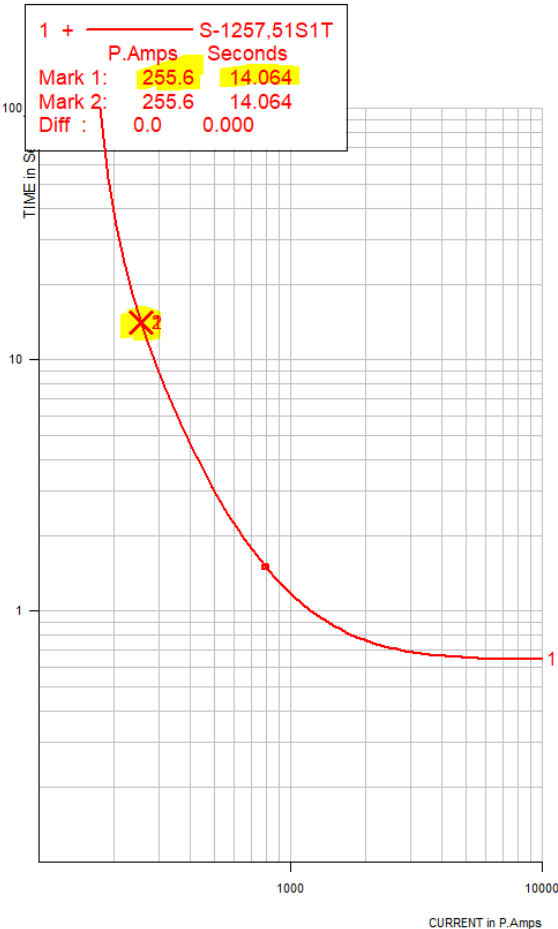
Root Cause Analysis – Primary Transfer Breaker Relay

- ❑ Ground TOC 51S1 pickup is 160 amps, primary
- ❑ With 255 amps 3I0, 51S1T trip would occur in about 14 seconds after “B” phase was shorted

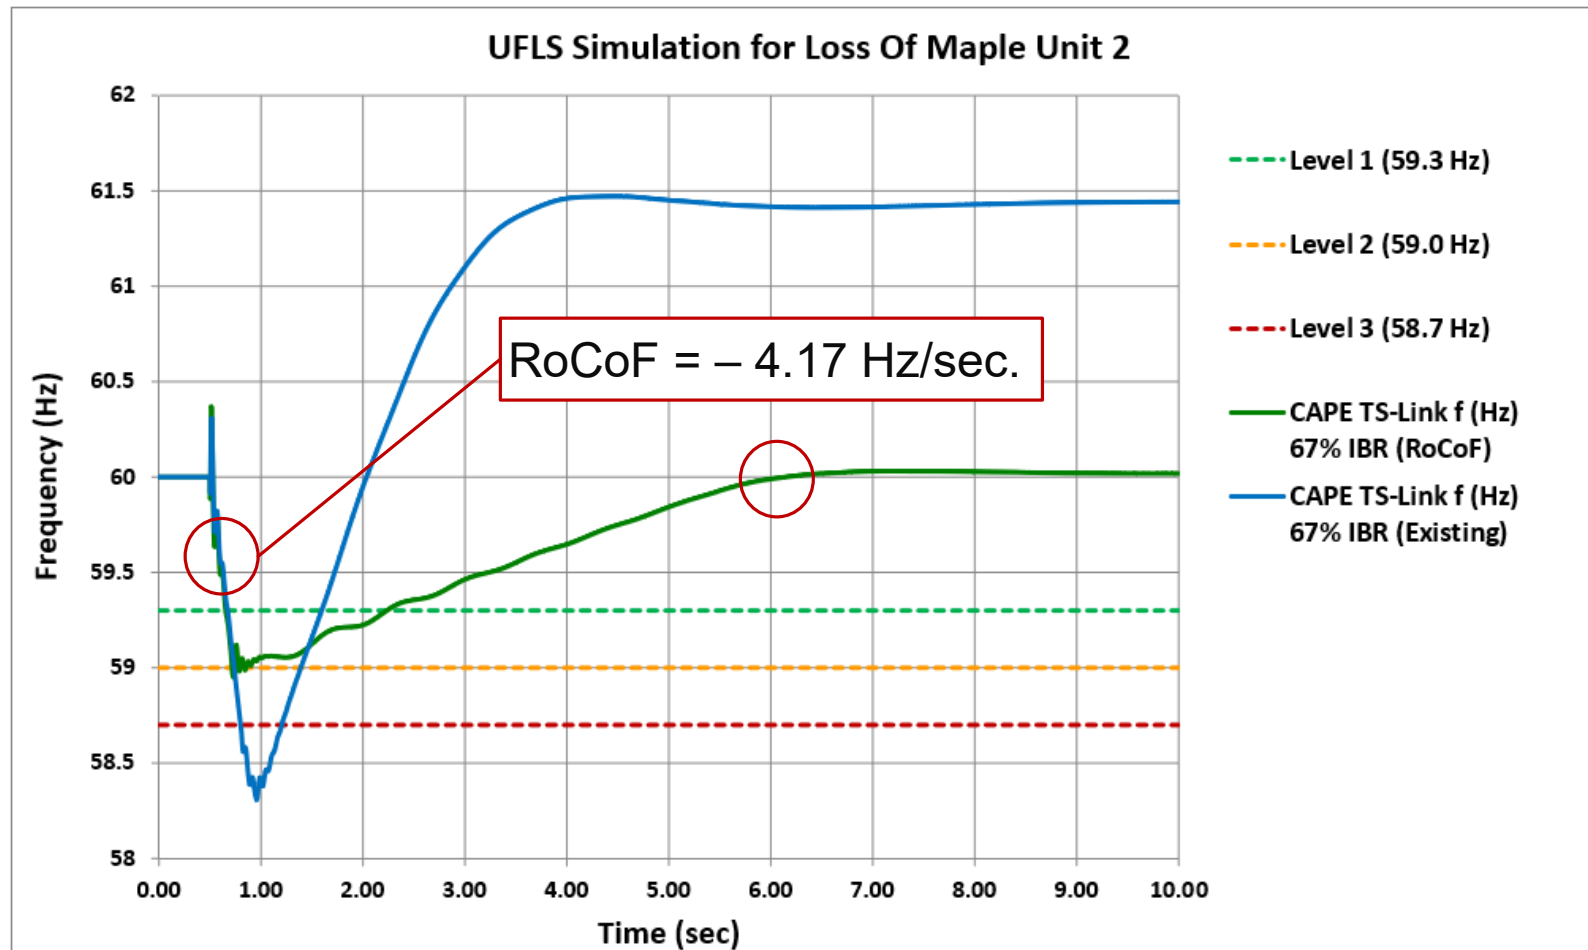
NEW Program Details and Performance

- ❑ CAPE TS-Link example for trip of 490 MW Maple Unit 2
- ❑ ONLY level 1 UFLS operates tripping 475 MW of load
